FACILITIES MASTER PLAN 2022

PLEASANTON UNIFIED SCHOOL DISTRICT

SITE FUNCTIONALITY ASSESSMENT

AMADOR VALLEY HIGH SCHOOL

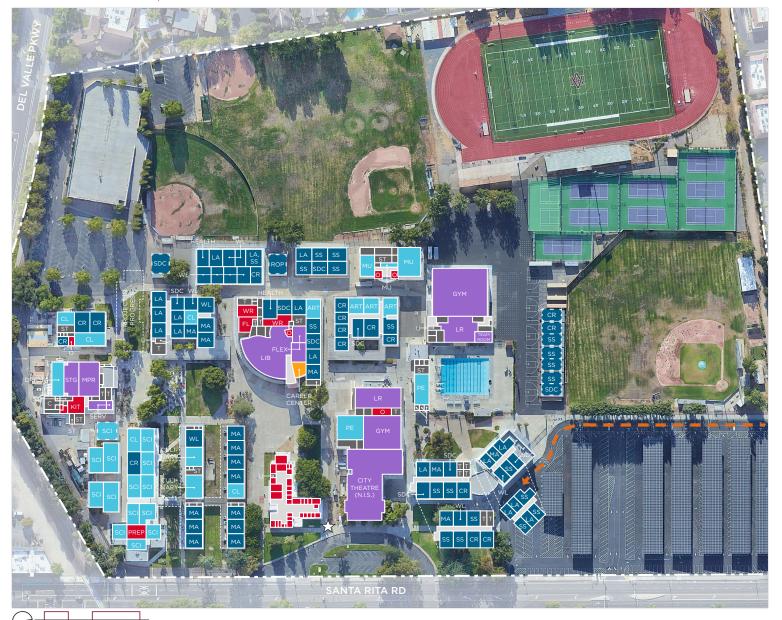
Existing Site Plan AMADOR VALLEY HIGH SCHOOL

Classrooms

Indicates Grade Level Social Studies Language Arts World Language WL Math

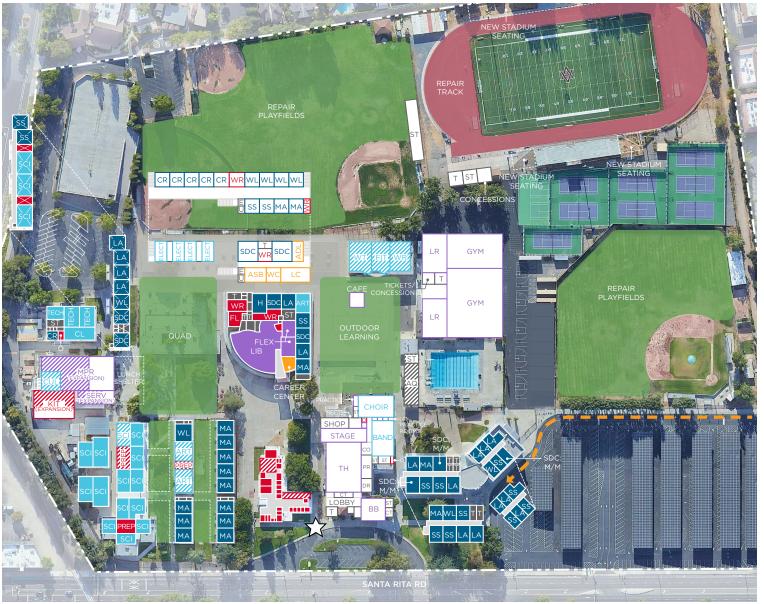
Proposed Master Plan Diagram

Classrooms

Classroom SS Social Studies LA WL Language Arts World Language MA

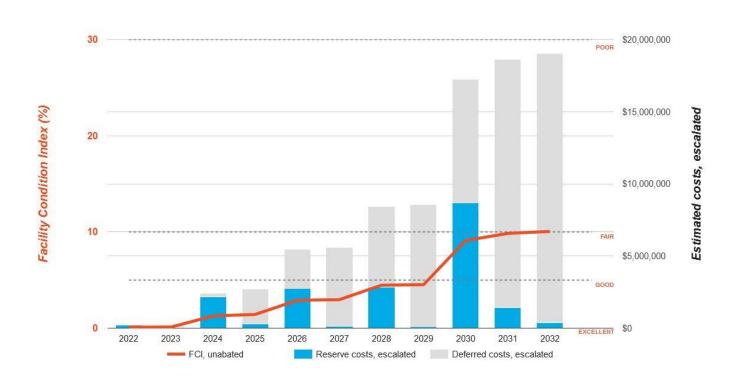
FCI Analysis: Amador Valley High School

Replacement Value: \$189,264,000 Inflation Rate: 3.0% Average Needs per Year: \$1,730,000

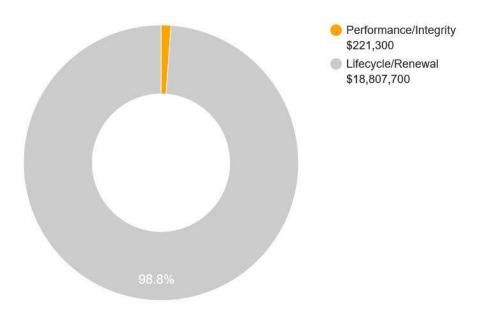
Plan Type Distribution (by Cost)

10-YEAR TOTAL: \$19,029,000
